B&Q Cricklewood ES Volume III

Appendix 12-4: Asbestos Report

Asbestos Survey Report

Property: **Cricklewood (390)**

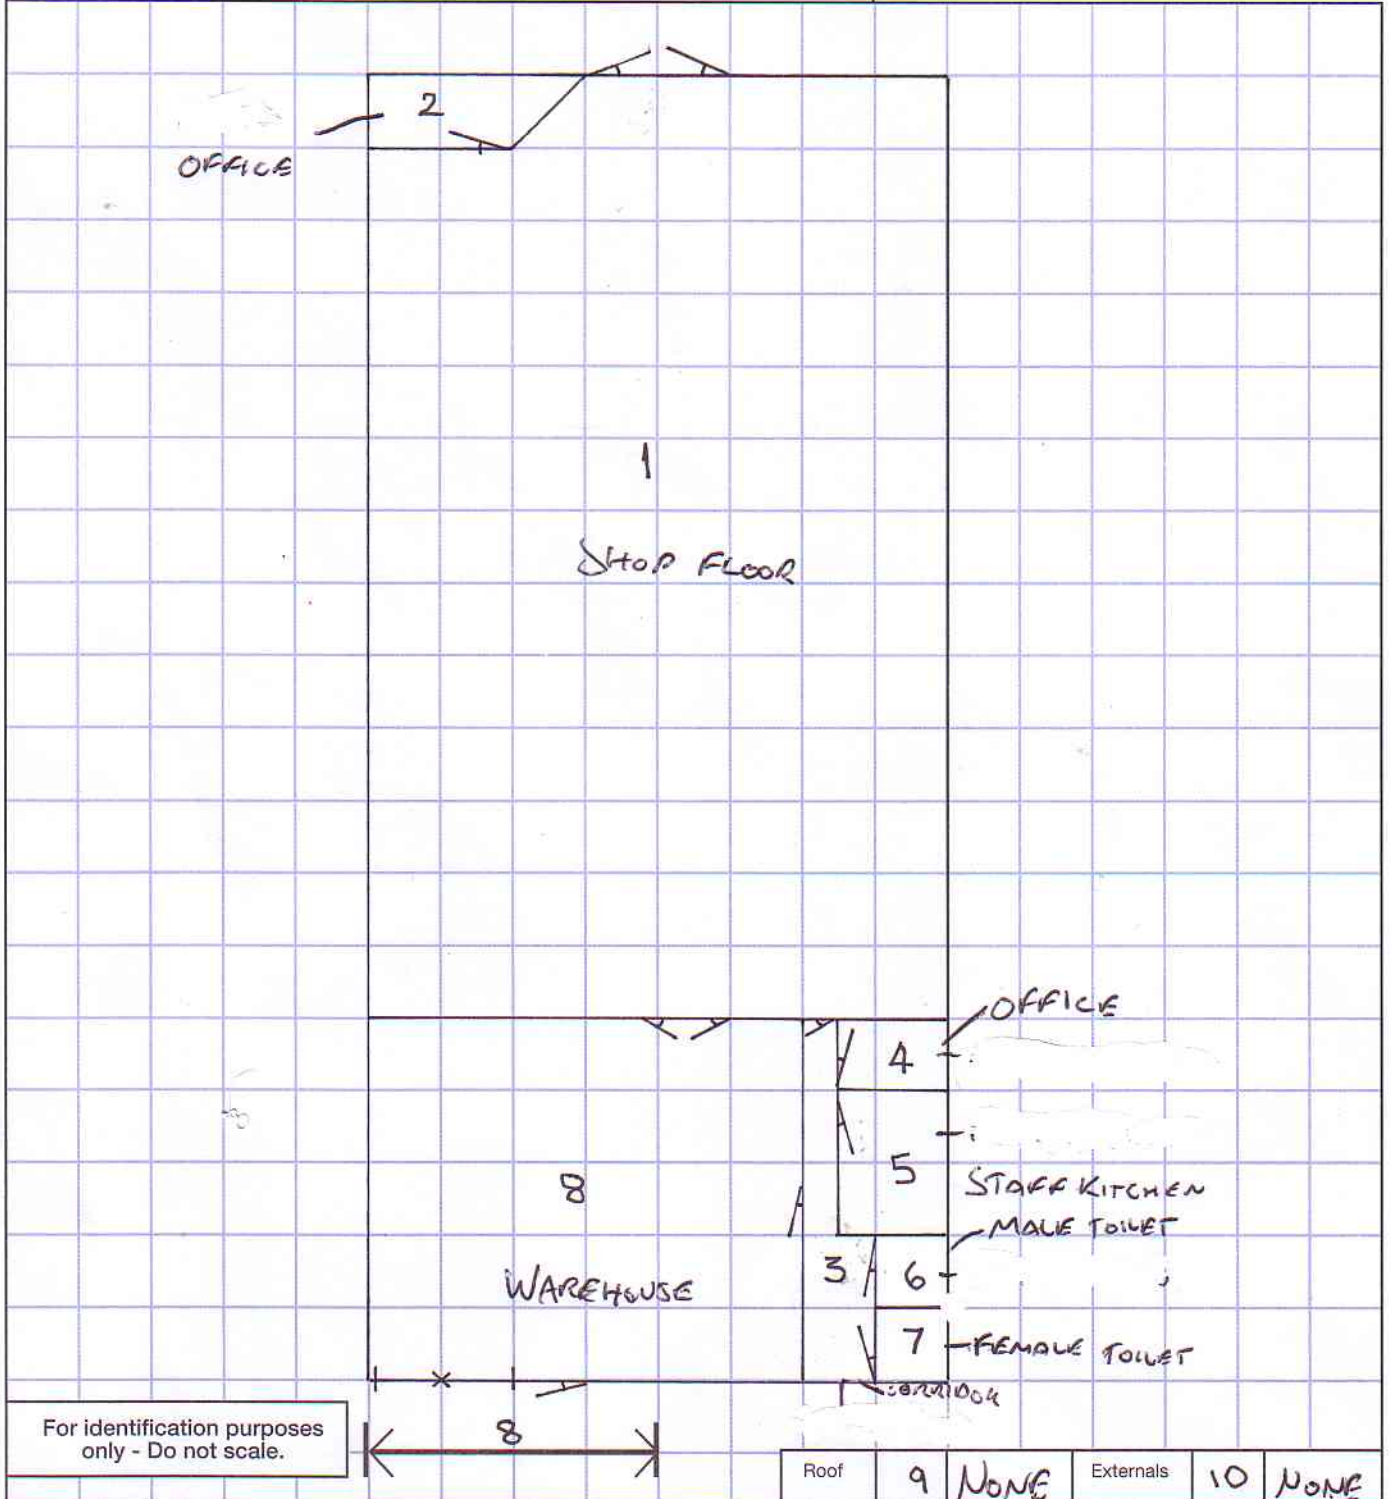
Task No.	122844	Survey Date	18 / 05 / 05	<b style="color: red;">North Point
Building Name	Unit 2 Broadway retail park Cricklewood			
Floor Level	Ground	Diagram No.	1 of 1

Roof	9	NONE	Externals	10	NONE
------	---	------	-----------	----	------
