B&Q Cricklewood ES Volume III

Appendix 12-3: Site Walkover
Photographs

Montreaux Cricklewood Developments Ltd

July 2020

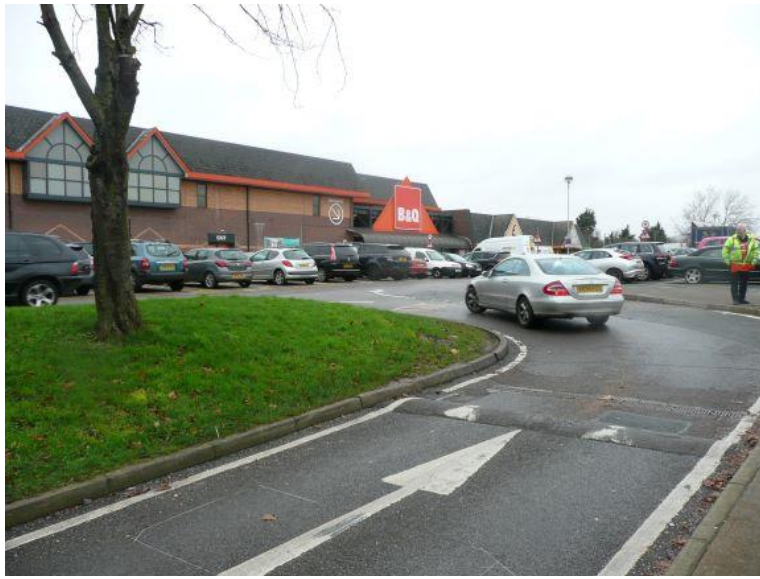
Photo No.
1

View of B&Q DIY Store
from the ramped access
road from Cricklewood
Lane.

The photograph aspect
is north-west.

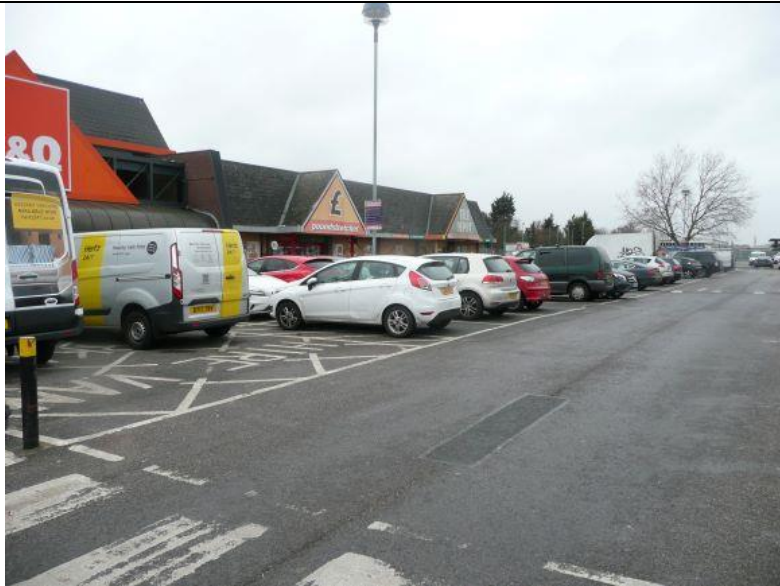
Photo No.
2

View of the Pound
Stretcher from the
parking area.

The photograph aspect
is north-west.

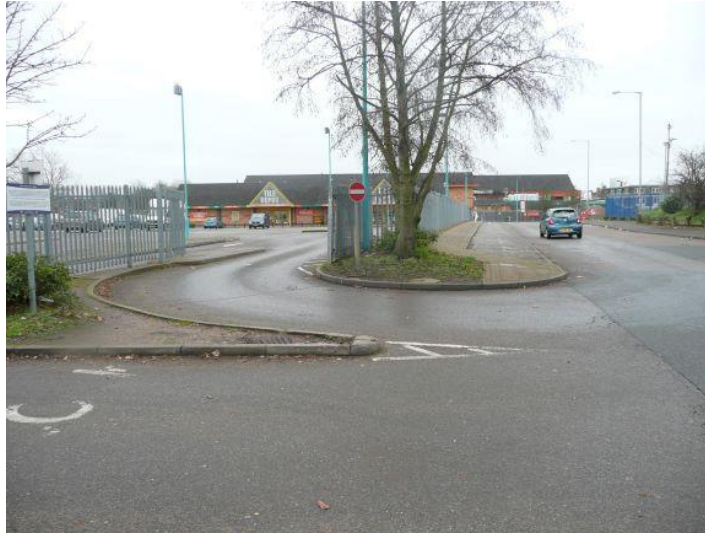
**Client Name: Montreaux
Cricklewood Developments Ltd****B&Q Cricklewood****Project No.
60608627****Photo No.**
3**Date:**
10
December
2019View of the Tile Depot
from Depot Approach.The photograph aspect
is south-east.

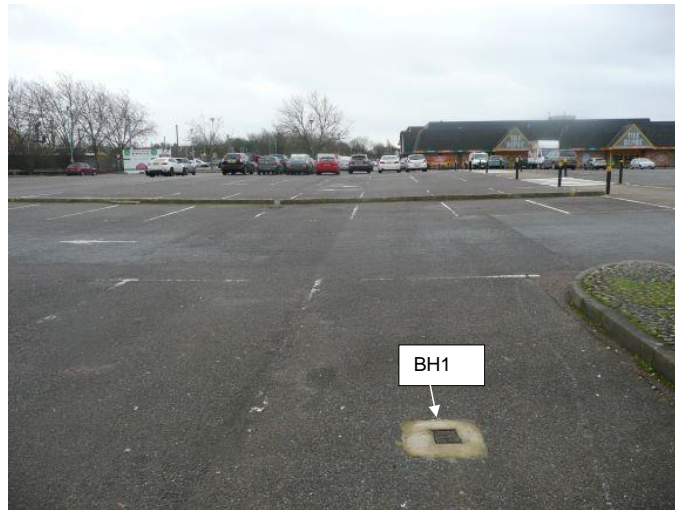
**Photo No.**
4**Date:**
10
December
2019View of the northern
aspects of the Site,
which consists of car
parking associated
with for the retail outlets.
Evidence of the previous
site investigation (BH1
borehole covers) was
observed in the parking
area.The photograph aspect
is south-east.

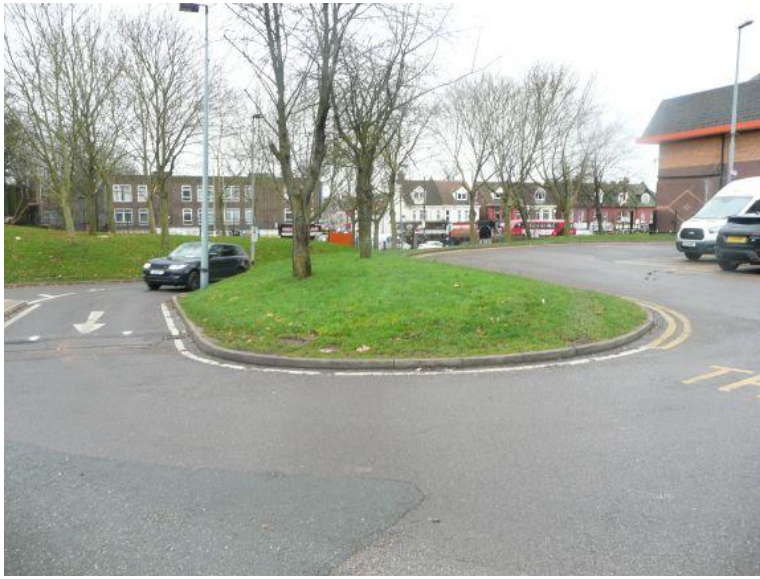
Photo No.
5

View of the soft landscaping adjacent to the southern entrance to the Site.

The photograph aspect is south.

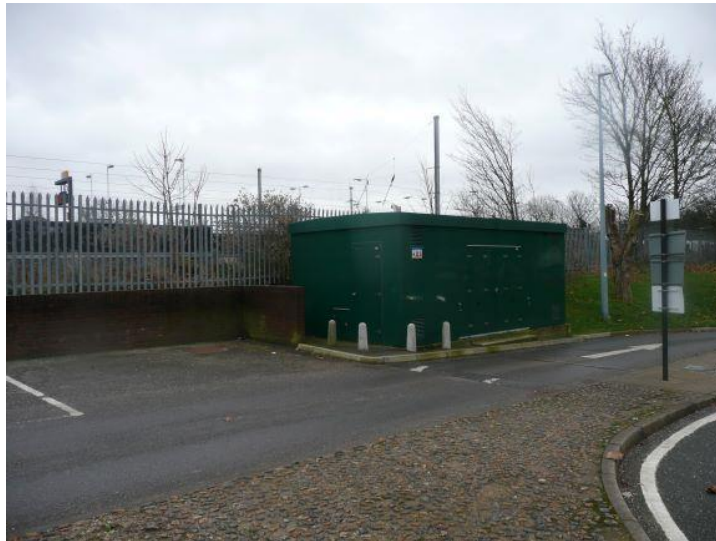
Photo No.
6

An electrical substation
gas governor station is located in the south-western corner of the Site.

The photograph aspect is south-east.

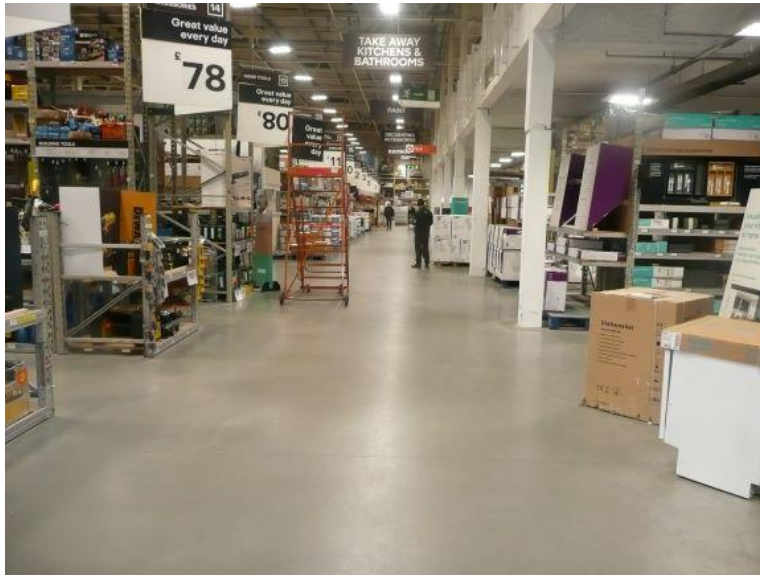
Project No.
60608627Photo No.
7Date:
10
December
2019View of the B&Q DIY
retail area.

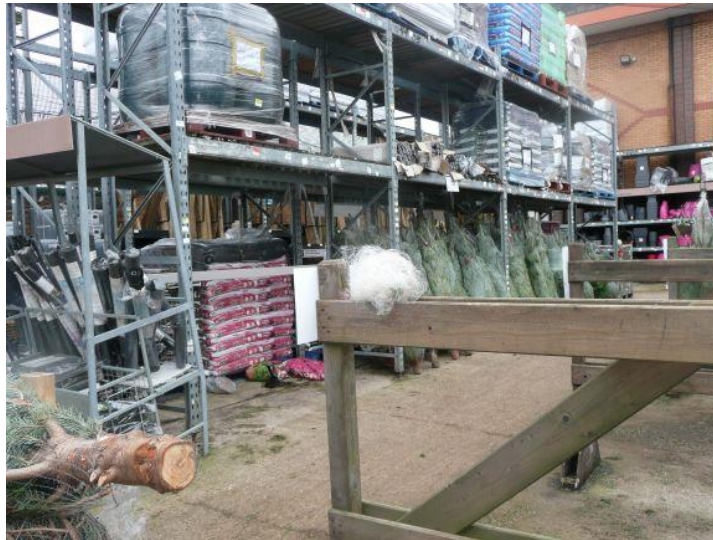
Photo No.
8Date:
10
December
2019View of the B&Q DIY
outdoor garden centre.The photograph aspect
is east.

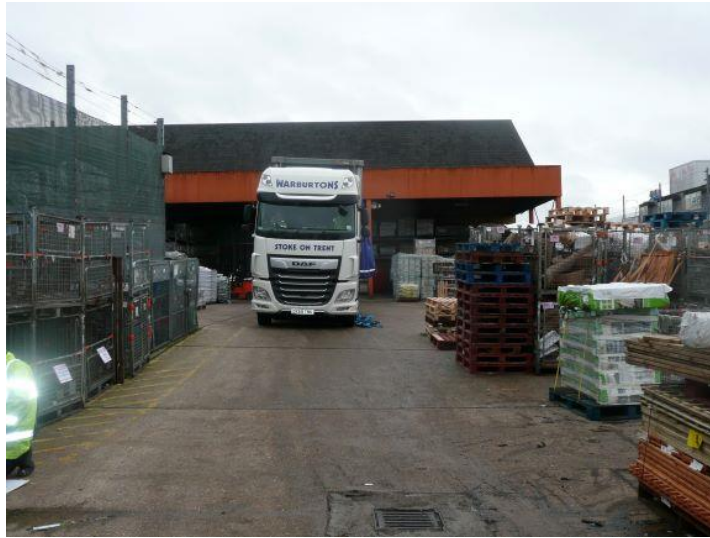
**Client Name: Montreaux
Cricklewood Developments Ltd****B&Q Cricklewood****Project No.
60608627****Photo No.**
9**Date:**
10
December
2019View of the B&Q DIY
outdoor service yard.The photograph aspect
is south-east.

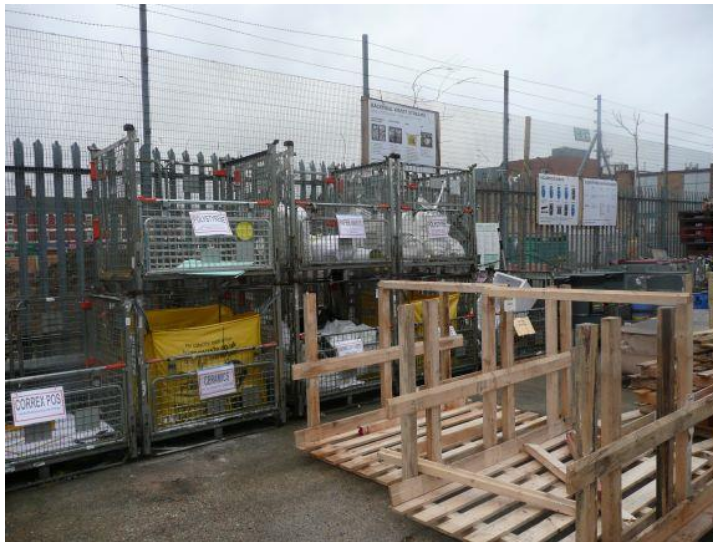
**Photo No.**
10**Date:**
10
December
2019View of the B&Q DIY
service yard, which
includes containers for a
number of waste types
(i.e. cardboard, shrink-
wrap, metal, clean
timber, polystyrene and
ceramics).The photograph aspect
is south-west.

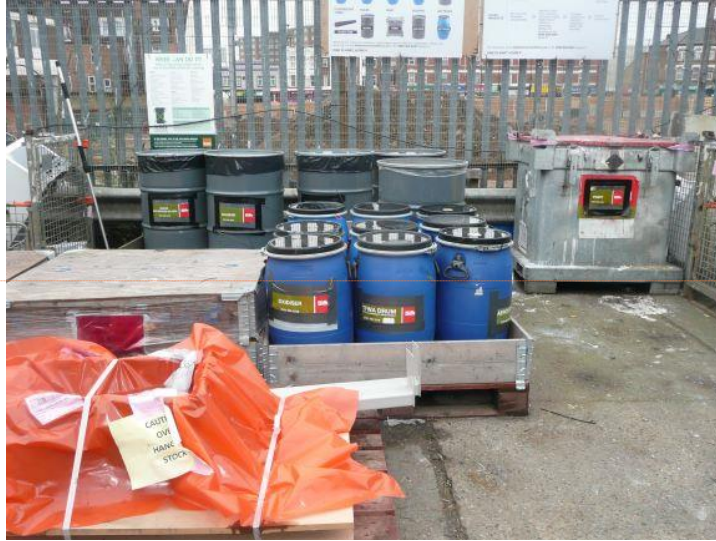
Photo No. 11
Date: 10 December 2019

View of the B&Q DIY service yard, which includes a number of sealed drums (labelled as 'aerosols', 'caustic', bulbs, consume, returned batteries, valpar, sand and absorber from spillages, rags and wipes from spillage).

The photograph aspect is south-west.

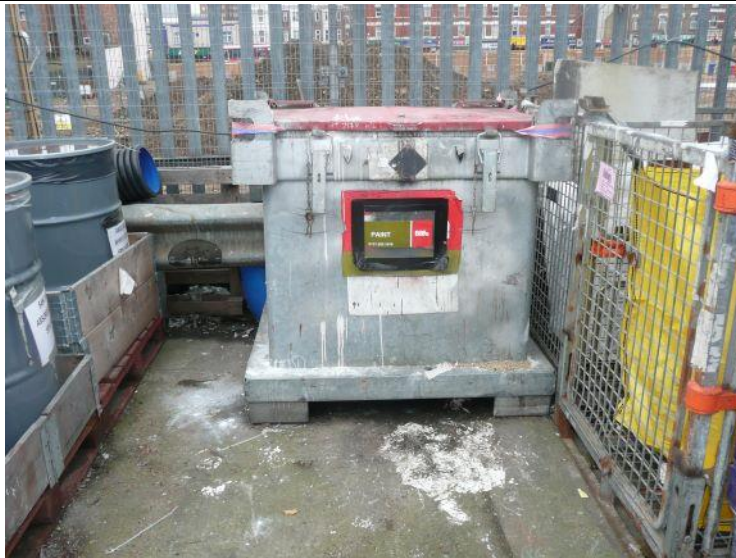
Photo No. 12
Date: 10 December 2019

View of the B&Q DIY service yard, which includes a container for paint.

The photograph aspect is south-west.

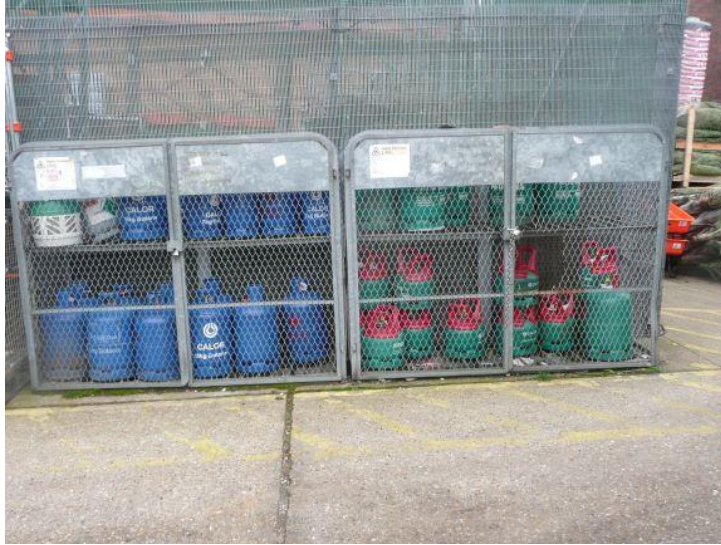
A flooded trench is along the eastern boundary and was reported to be for tree pits that will be being installed in the second phase of works for 2 Merchant Square View of LPG (Liquefied Petroleum Gas) canisters in the B&Q DIY service yard.

The photograph aspect is east.

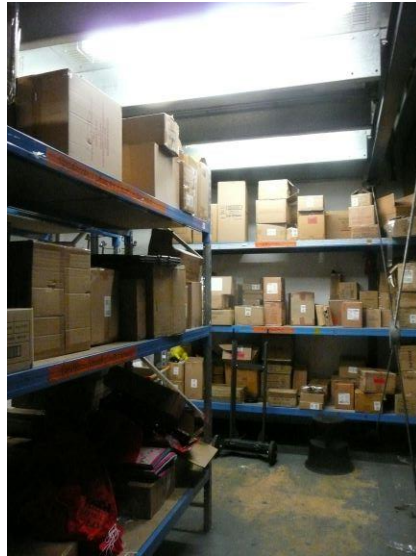
**Photo No.**
14**Date:**
10
December
2019

View of the Pound
Stretcher storage area.

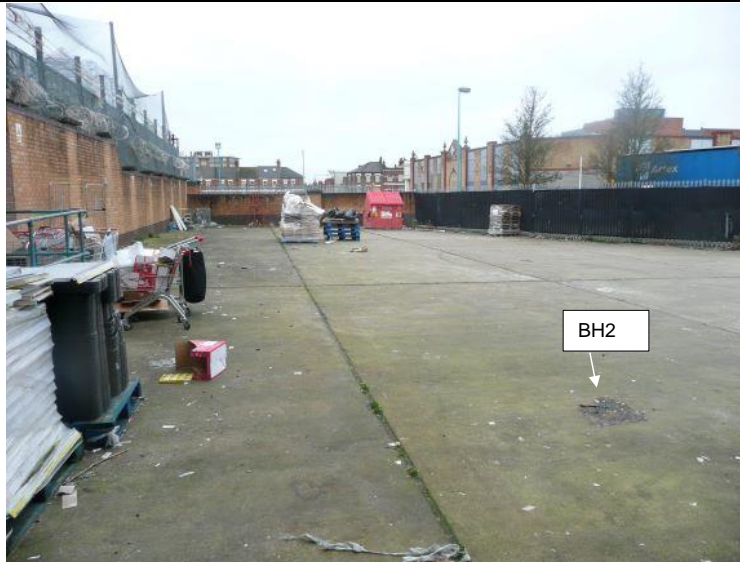
A flooded trench is along the eastern boundary and was reported to be for tree pits that will be installed in the second phase of works for 2 Merchant Square View of the Pound Stretcher back yard. The back yard is concrete, in generally good conditions. Evidence of the previous site investigation (BH2 borehole cover) was observed in the back yard

The photograph aspect is south-east.

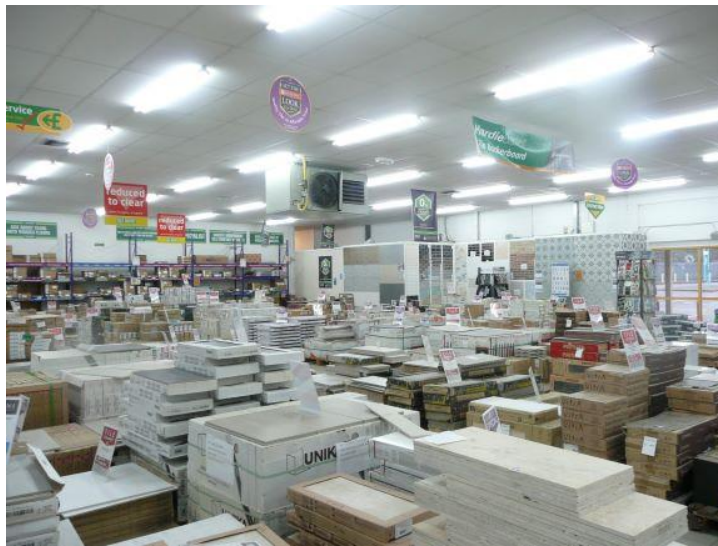
**Photo No.**
16**Date:**
10
December
2019

View of the Tile Depot retail area

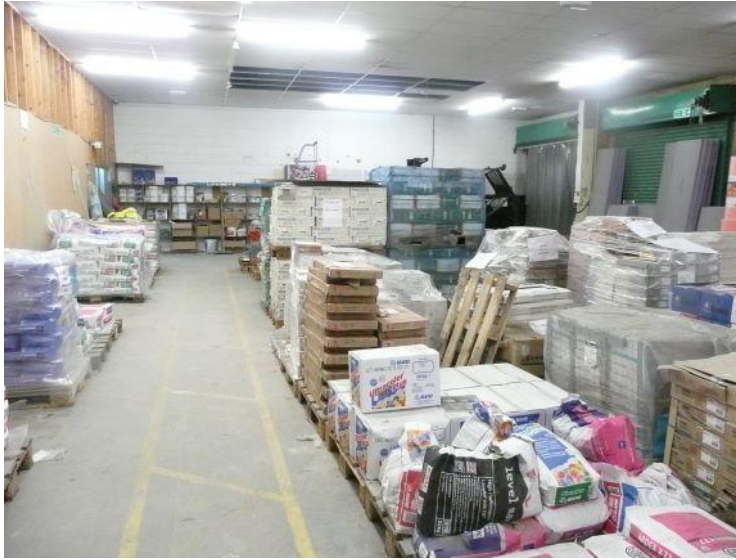
**Client Name: Montreaux
Cricklewood Developments Ltd****B&Q Cricklewood****Project No.
60608627****Photo No.**
17**Date:**
10
December
2019View of the Tile Depot
storage area.

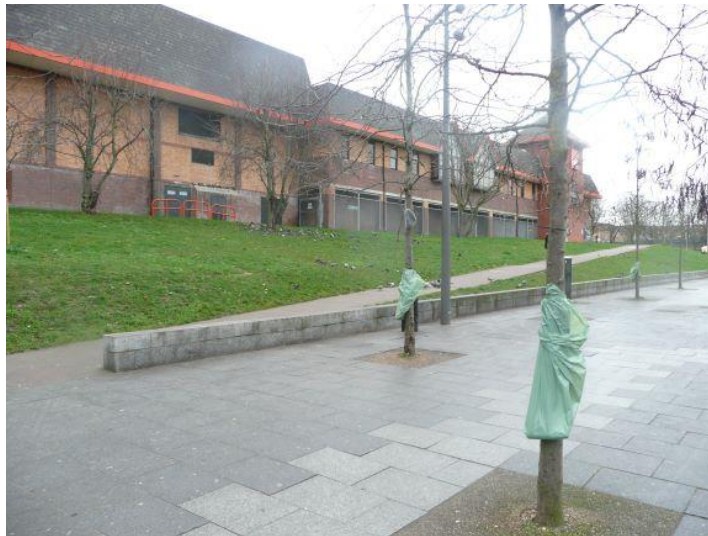
**Photo No.**
18**Date:**
10
December
2019View of the southern
boundary of the Site,
which is elevated
compared to
Cricklewood Lane.The photograph aspect
is east.
